CLEARLINE PROFILER CASE STUDY

FAILURE OF NEWLY LAID PVC

Location: Rodney, Auckland New Zealand
Pipe Size: 36inch
Age of Pipe: 4 months
Pipe Type: Polyvinyl Chloride (PVC)

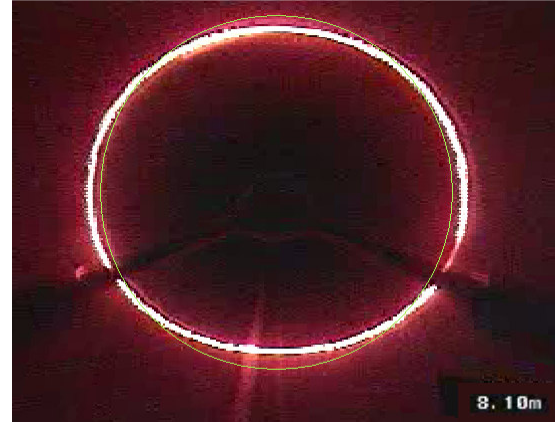
Results: Deflection and Ovality thresholds set to five year allowable limits of 7.5%. After 4 months one of the pipes has already failed in one section while others are showing signs of early failure.

Engineers highlighted areas for re-excavation and re-compaction before adoption was completed.
