# MEASURE ... CORROSION

102391 - Year 1966 - 635mm ID, 762mm OD – Concrete – (104m)

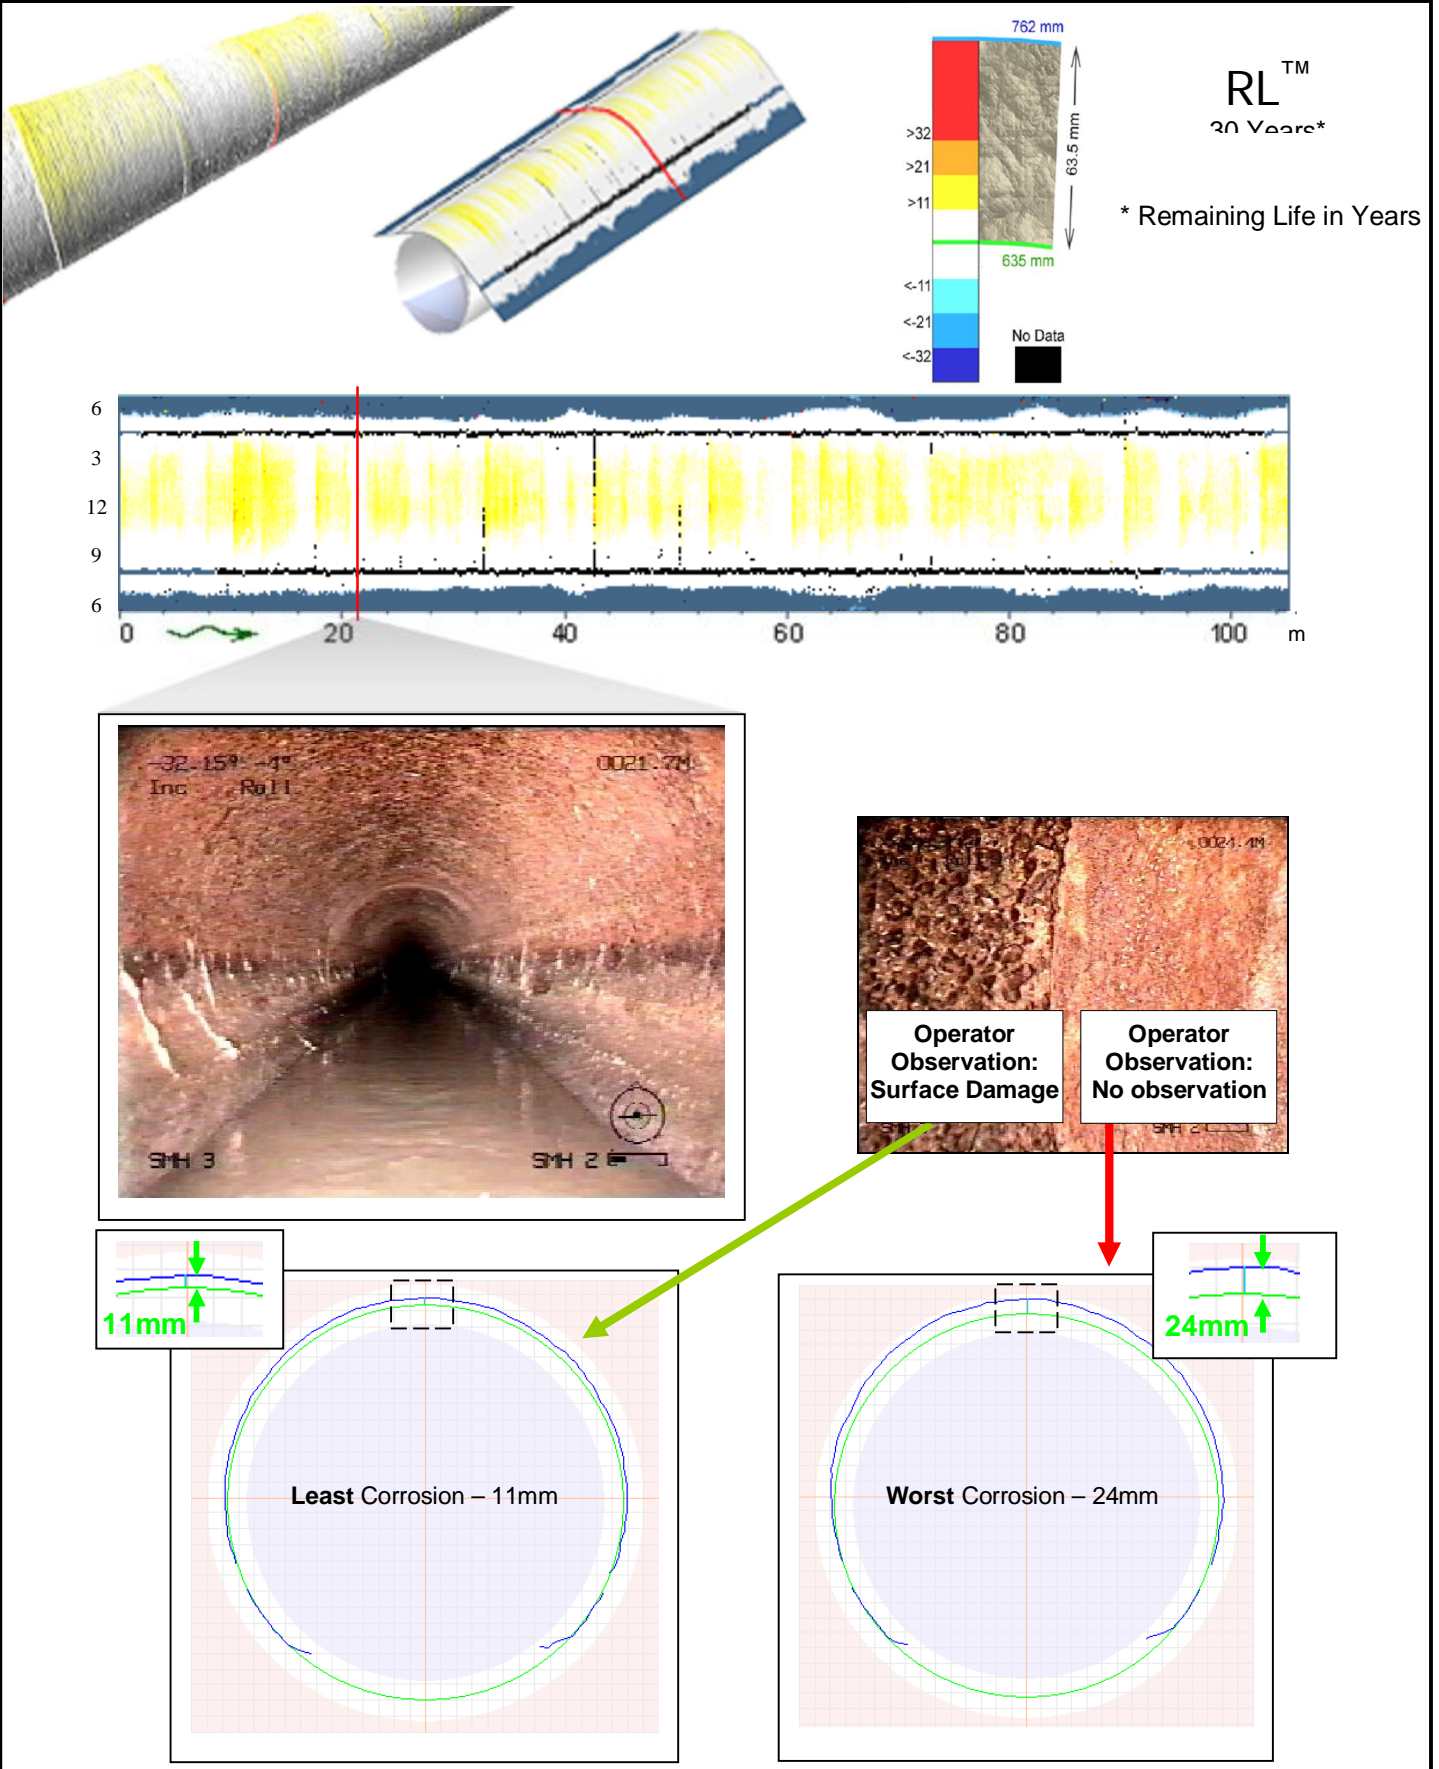
- The internal diameter was in fact 635mm (initially recorded as 675mm)
- An undocumented 20mm sacrificial layer had been applied to the pipeline prior to install.
- There are instances where the host pipe has been exposed but there is no evidence of the host pipe starting to corrode.
- As the host pipe is 64mm thick we would estimate that the pipe has many more years of active service before rehabilitation would be required.
- We would recommend a further survey in 3 years time to start a process of quantifying the corrosion effect over time.
