MEASURE ... Pre & Post Cleaning

203172 - Year 1964 - 787mm ID, 939mm OD – Concrete – (200m)

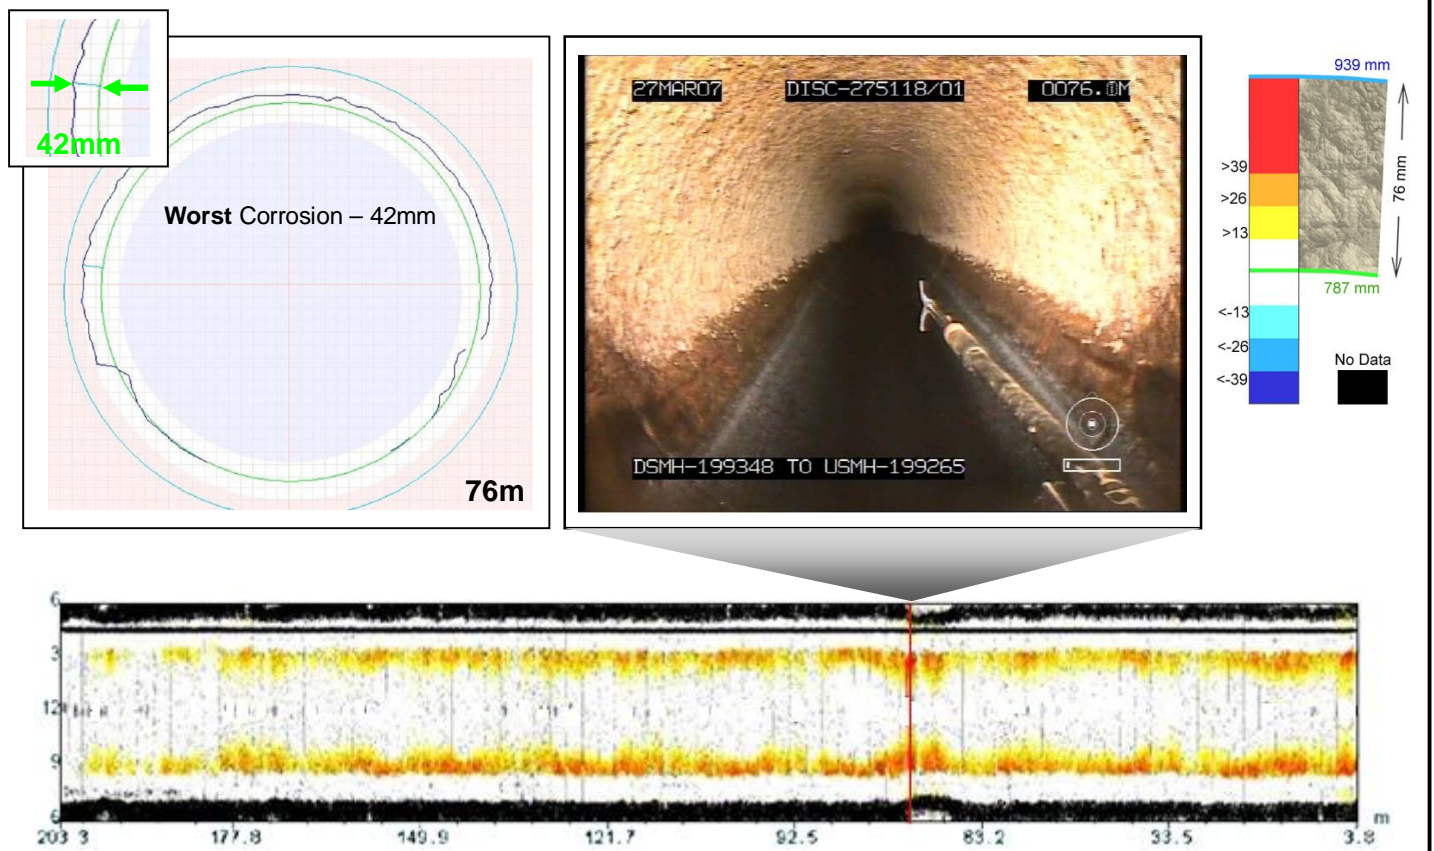
Pre-Cleaning

- The “match to reference” size is found to be 787mm
- No significant greasy build-up visible on the pre cleaning profile reports, if anything there was a fine layer of dust evident
- Corrosion through the expected rebar is evident over more than 50% of the pipe length.
- Wall thickness assumed to be 76mm - Corrosion to 42mm.

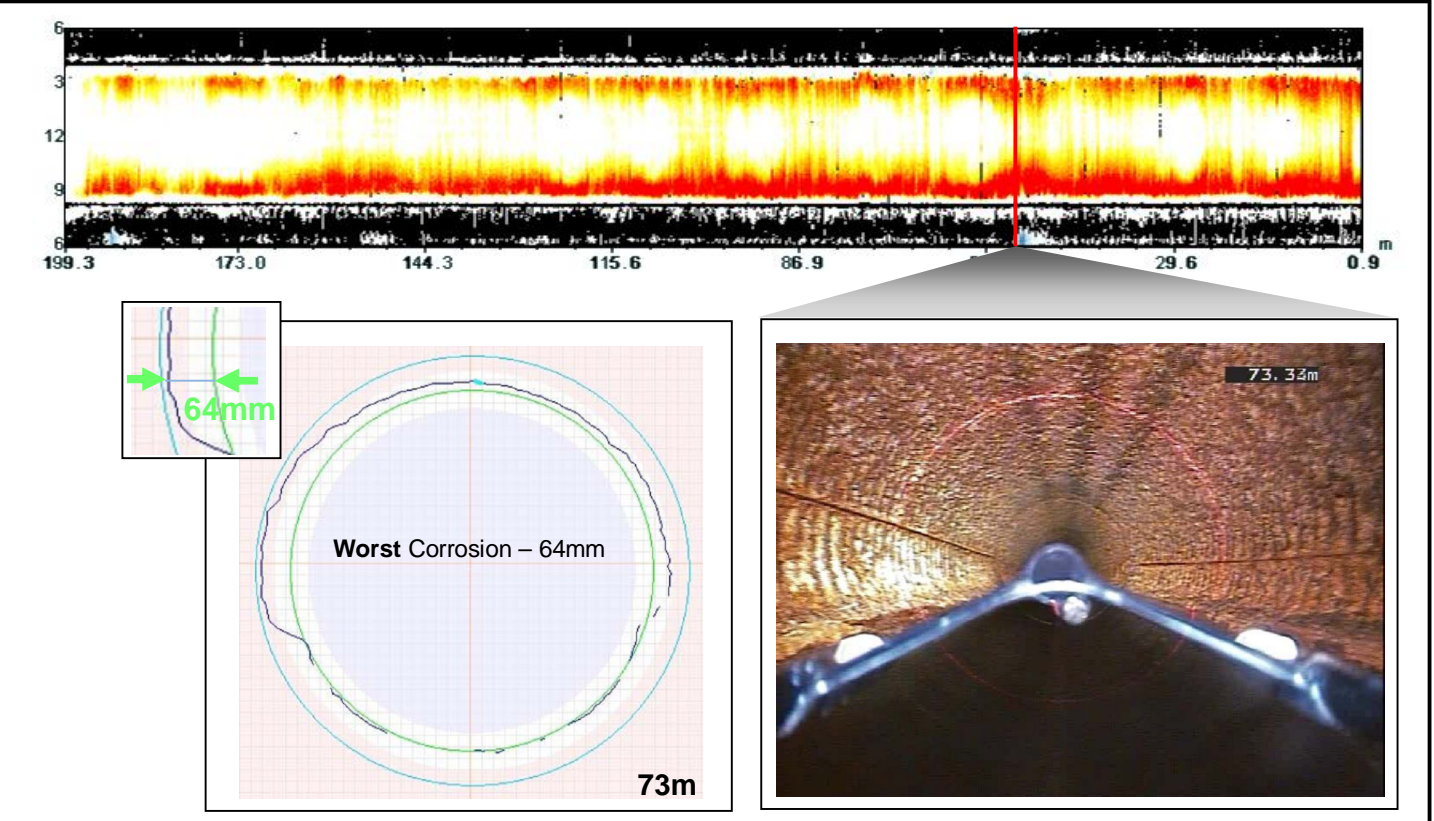
Post-Cleaning

- The match to reference size is found to be 787mm.
 - No concrete removed at this point
 - Heavy cleaning did not reach this part of the pipe
- 0.7 metric tonnes of concrete removed.
- Corrosion through the expected rebar is evident over more than 85% of the pipe length.
- Dark slime covering the invert has not been removed.
- Wall thickness assumed to be 76mm - Corrosion to 64mm.

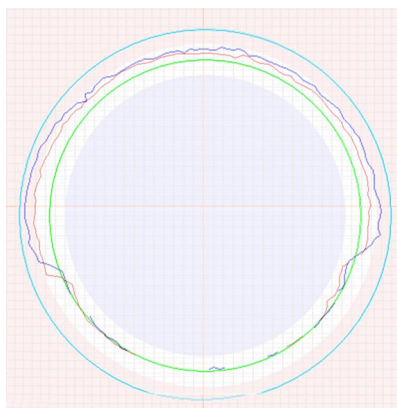
After comparing the two separate runs it was seen that the same corrosion pattern is clearly evident, however through the cleaning process a significant amount of material had been removed in some cases more than 20mm of pipe wall had been “cleaned away”.
